FRAMELESS GLASS BALUSTRADE

Test Report Number: 163383 (QT41067/1/JPS)/Ref. 1

Report Date: 09 August 2016

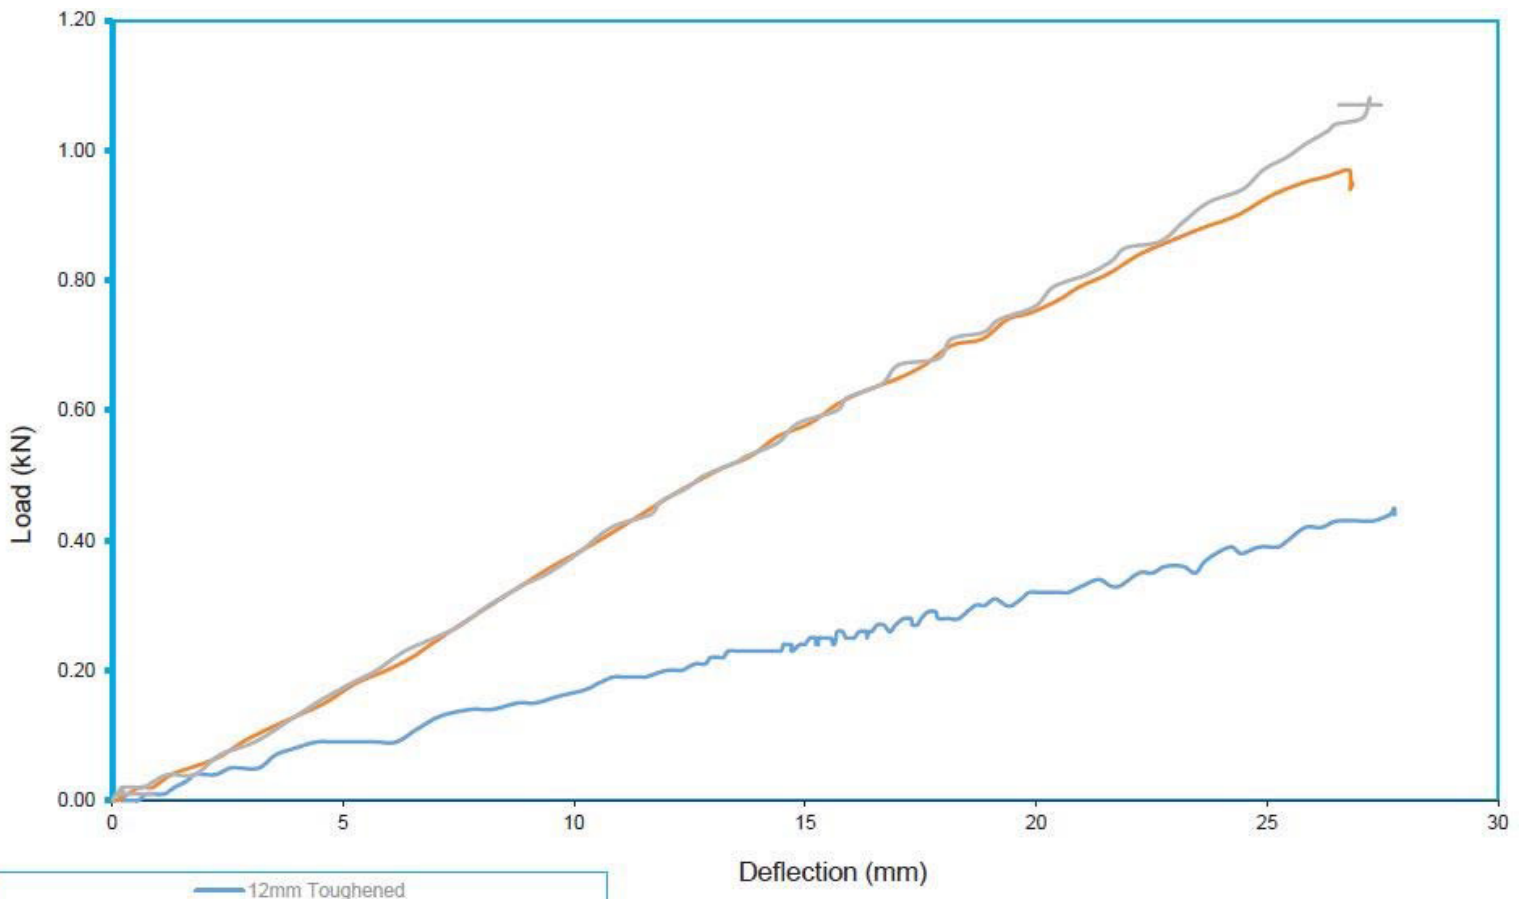
Key

- 12mm Toughened
- 15mm Toughened
- 21mm Laminated EVA

Deflection (mm)

Glass Span mm	Glass Type	Test Height mm	Imposed Line Load Deflection at 25mm Deflection kN/M	Working Line Load for System kN/M	Deflection at Working Line Load for system mm
1000	12mm Toughened Monolithic	1100	0.39	0.36	22.8
1000	15mm Toughened Monolithic	1100	0.92	0.74	19.38
1000	12mm Toughened Laminated	1100	0.98	0.74	19.21

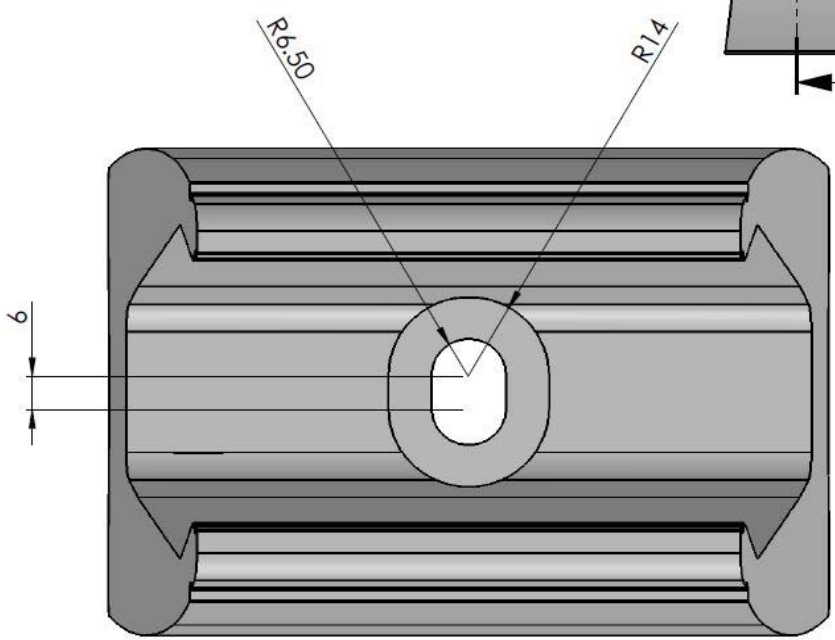
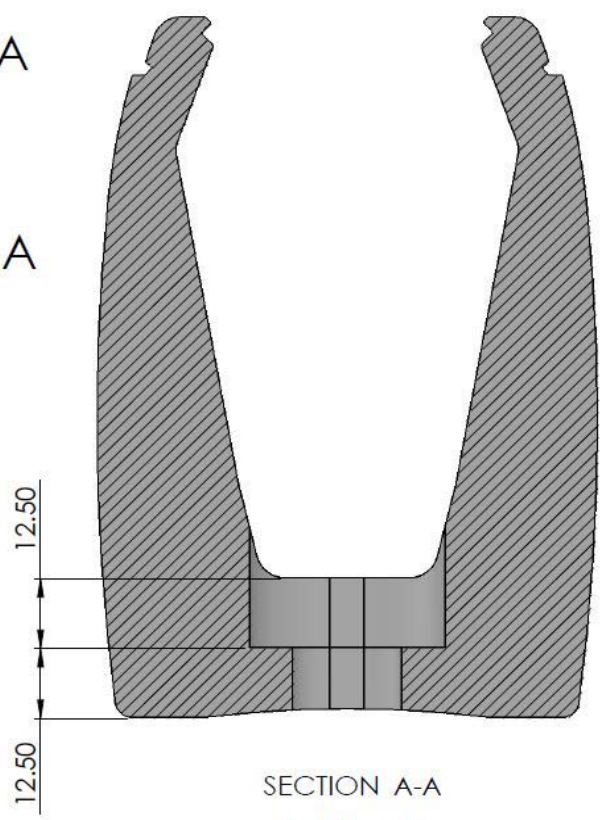
The Spig-Lite Pro adapters were bolted at 500mm centres (250mm in from the edge of a 1000mm wide glass panel) to the top of the concrete slab, which was fixed to the floor of the test facility. Two spigots were fixed per metre using a single 12mm bolt per spigot. A glass panel of appropriate width and thickness was fitted into the spigots using the glass slip clamping system.

A horizontally imposed line load was applied to the glass at a height of 1100 millimetres above the datum level of the floor and the deflection measured at the top central point of the panel 1100 millimetres above the datum level of the floor. The load was applied via a hydraulic ram and the deflection measured using a linear voltage displacement transducer.
